**RE: Town of Beekmantown
Salt Contamination Investigation
2nd Quarter 2019 Progress Report
AES Project No. 4461B**

Town of Beekmantown

Salt Contamination Investigation

(2nd Quarter 2019)

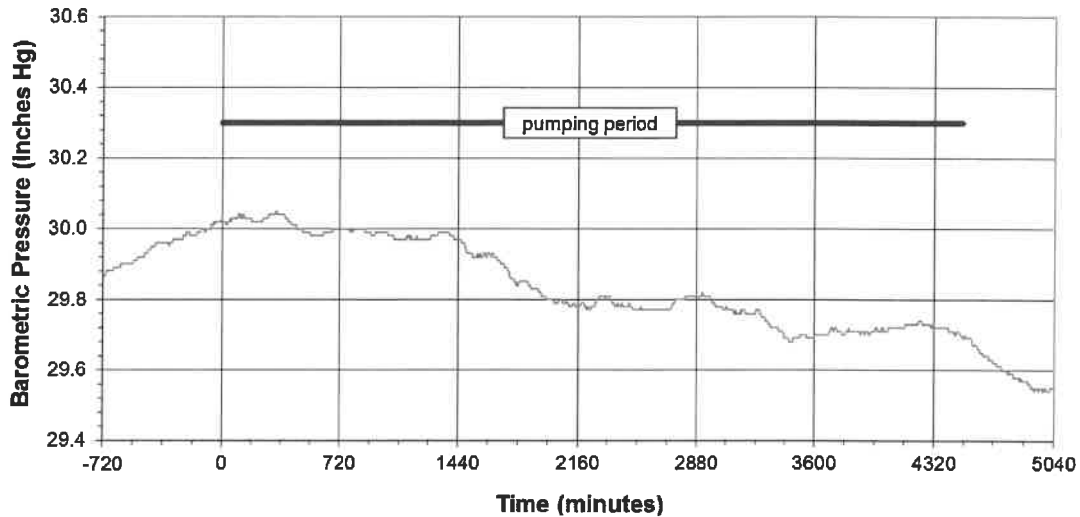
Figure 3 - Barometric Pressure

Figure 3 is a graph of barometric pressure. The pressure data was used to make a barometric correction of the data from the transducer used to measure water levels in Well TW-1.

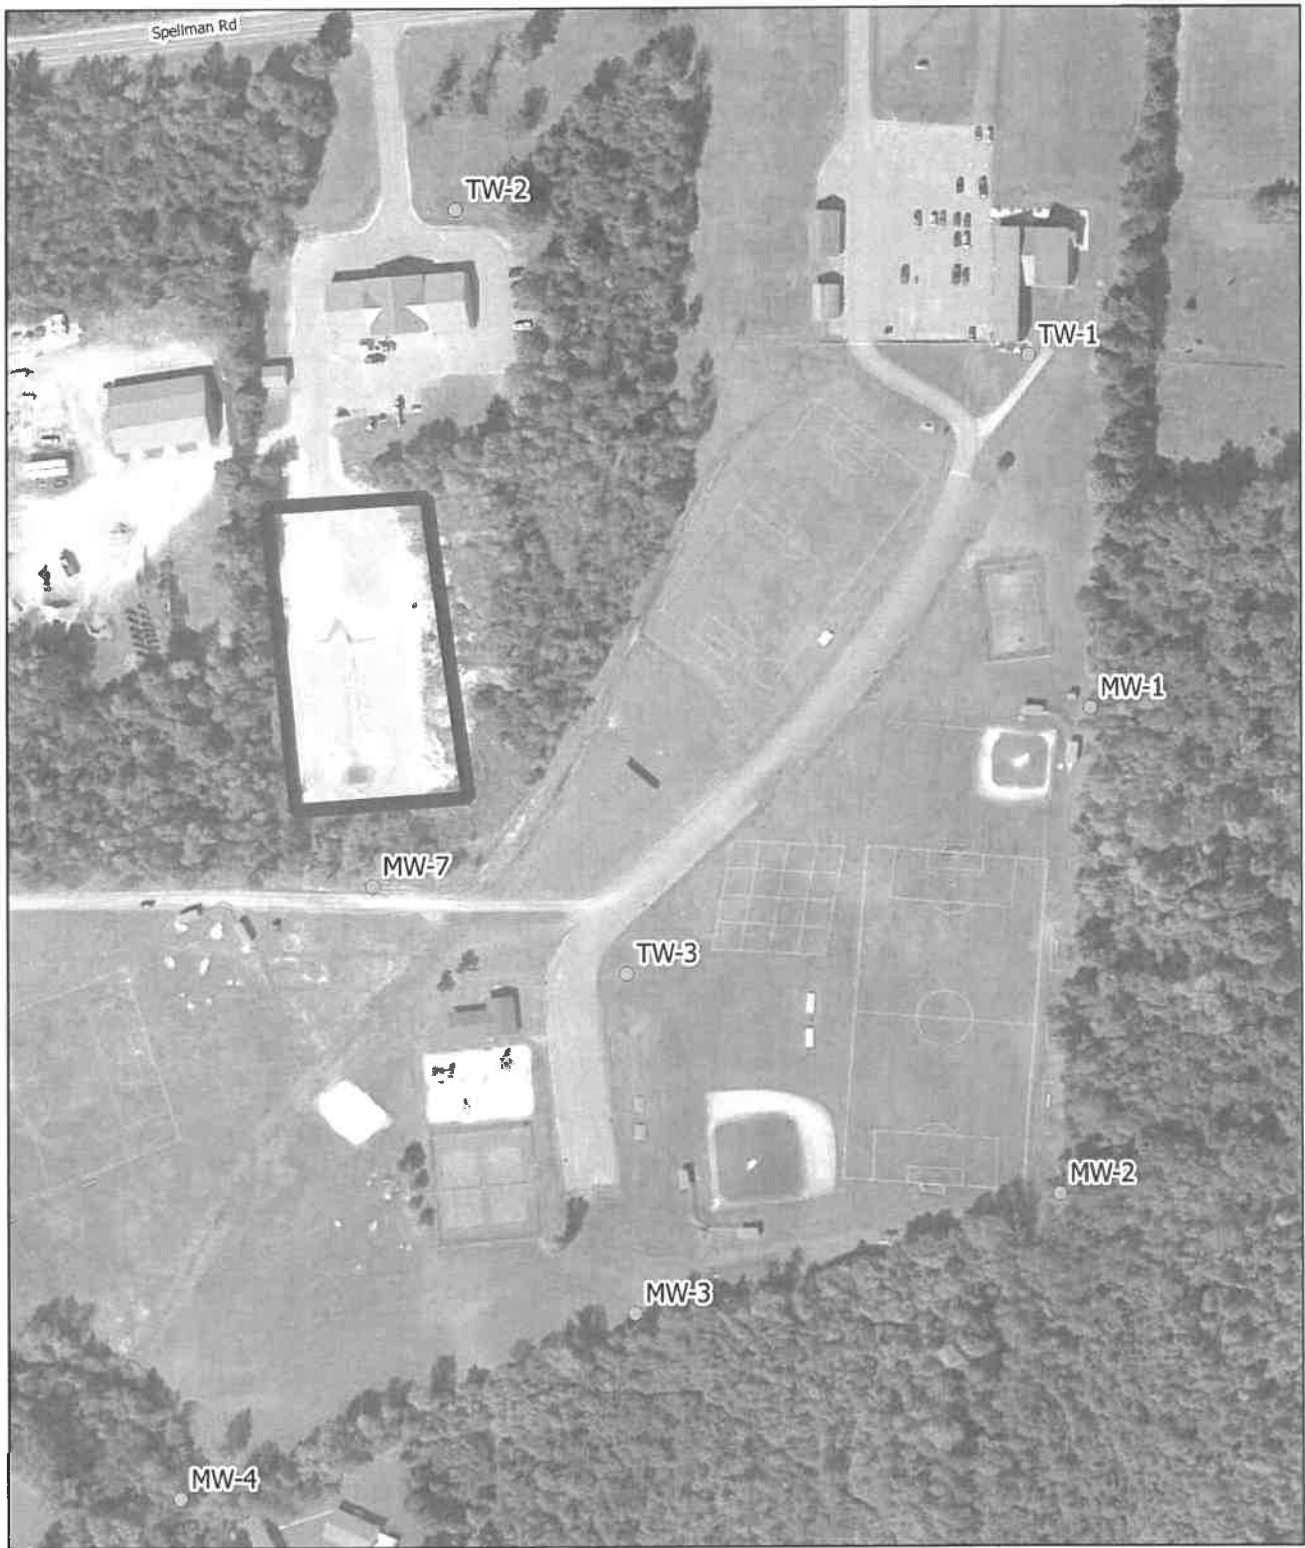
Monitoring Points - Water levels were measured manually in a collection of seven additional wells near TW-1. All of these wells had been part of the program of quarterly sampling for chloride contamination. Figure 4 shows the locations of all the wells monitored during the test. Table 1 lists the wells monitored during the test, and gives their distance from the pumping well.

- Wells
- Salt storage area

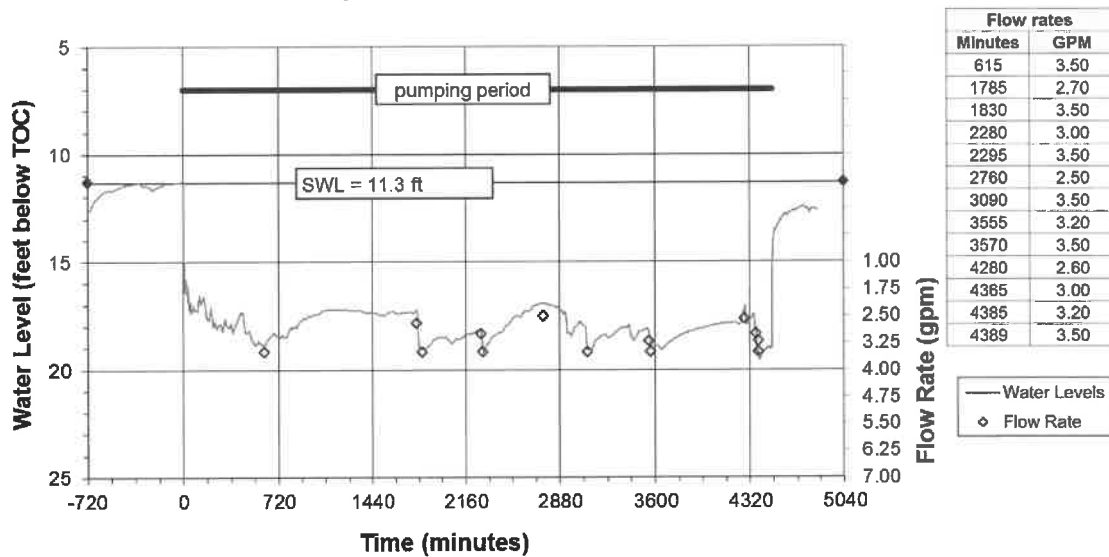
Figure 5 - Water Levels in Well TW-1

It is not clear that the rain event on the second day of the test had any influence on water levels in the limestone aquifer, based on inspection of Figure 5. The water level fluctuations caused by the varying flow rate overwhelm any rain-induced water table changes.

When the pump was shut off, the water level rebounded by about 5 feet in the first 10 minutes. After that, the recovery was more gradual, and when recovery measurements terminated after about six hours, the water level was still about 2.5 feet lower than it had been when the test started. Although this is not promising behavior, it has to be remembered that the test was not actually run at a constant rate; a prolonged period of pumping at less than 3 gpm was followed by a brief period of pumping at 3.5 gpm, and this complicates interpretation of the recovery curve. A comparison of drawdown and recovery at corresponding times appears more promising. The first 240 minutes of pumping Well TW-1 produced drawdown of 6.51 feet. The first 240 minutes of recovery produced a water level rebound of 6.56 feet. Overall, this may suggest there is a lower risk that the well would decline in yield.

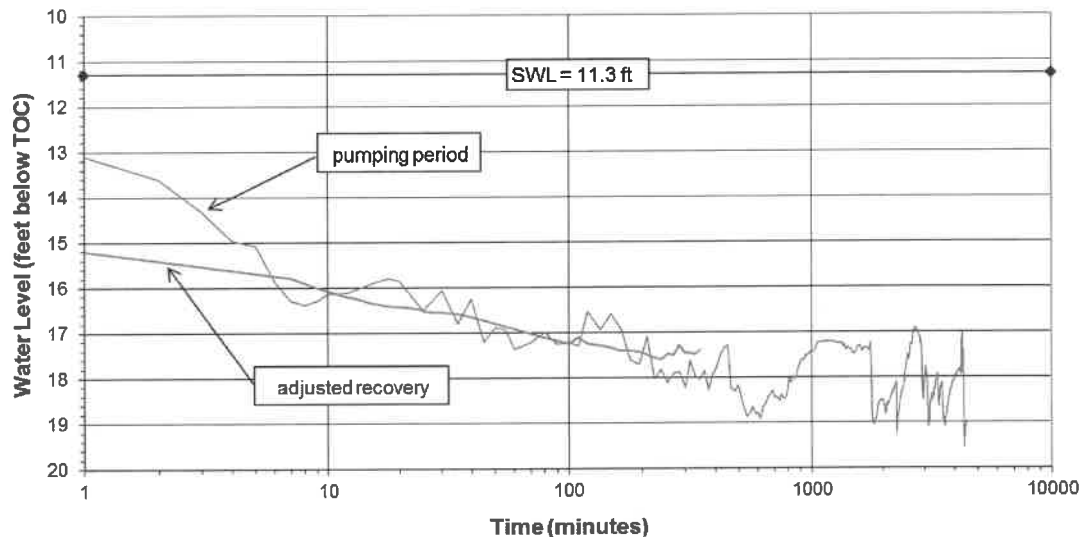
Figure 8- Comparison of Drawdown and Adjusted Recovery

Figure 8 is a semilog graph comparing the drawdown trend with the recovery trend. To produce this graph, the graph of Figure 6 was used as the base, and the recovery water levels were adjusted by inverting the curve and adding an arbitrary offset value to produce the best match of the trends for the time from 10 minutes to 300 minutes. The graph shows that recovery performance was a close match for drawdown performance, after accounting for the spikes in the drawdown data caused by flow rate adjustments. By this measure, recovery performance could be judged as adequate, for the average flow rate of 3.2 gpm.
